PHASE I INSPECTION REPORT
NATIONAL DAM SAFETY PROGRAM

JORDAN DAM
WILSALL, MONTANA
PARK COUNTY
MT 334

HKM ASSOCIATES
BILLINGS, MONTANA

APRIL 1981

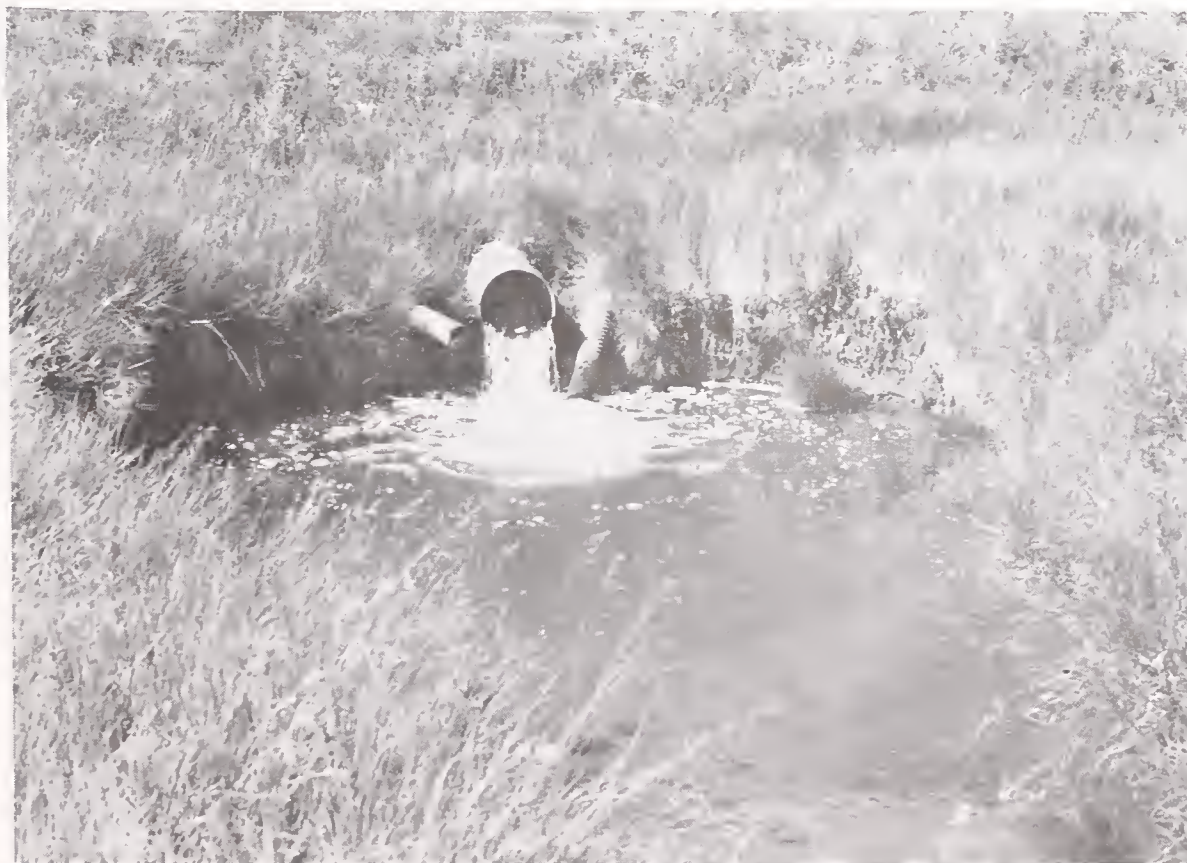
The outlet pipe and stilling basin are located in alluvium. During the field inspection it was noted that erosion is occurring along the stilling basin perimeter. The stilling basin erosion has progressed downward to bedrock, a depth of about 4 feet.

Bank erosion was observed in the natural soils of the right abutment (Photo 11 of Appendix B) and the natural alluvial soils in the stilling basin (Photo 2 of Appendix B). This erosion is the result of wave action undercutting the shoreline and causing sloughing up to about 3 feet in vertical height.

Photo No. 2 - Stilling Basin.
The earthen walls of the stilling basin are
vertical due to erosion.

- (3) Reshape the stilling basin earthen sidewalls and place properly designed rock riprap throughout the basin.
- (4) Perform the following work on the low-level outlet: identify the cause of the gate stem casing break and perform the necessary corrective measures; repair the gate stem casing and refill with oil; improve the foundation of the concrete pedestal; inspect the low-level outlet pipe throughout its total length when the pool is at a low level, and make the necessary repairs before raising the pool; check the gate for full operational capability when the principal spillway is not flowing, which would approximate the maximum hydraulic head condition, and when the reservoir pool is at a low level, which will minimize downstream damage; and perform the necessary repairs to the stilling basin (see Recommendation 3).

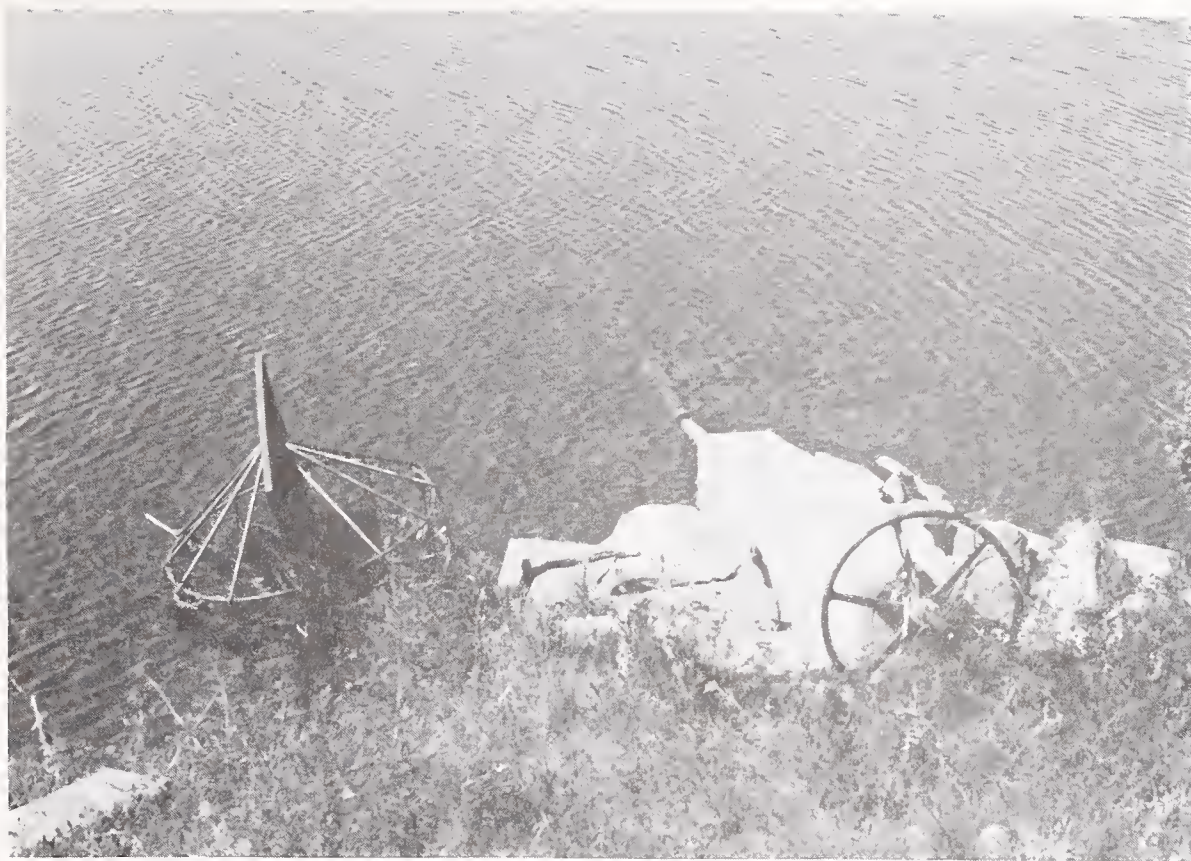
It appears the spillways have performed satisfactorily in the past. The principal spillway conical trash rack is tilted, but it does not appear to affect the spillway hydraulics. The principal spillway is capable of passing high flows. No detrimental effects would occur except for possible damage in the stilling basin and in the return channel. This particular damage is not considered critical to dam safety unless the high flows are passed for a very long, sustained period of time and damage progresses into the dam embankment. It appears that the principal spillway conduit will operate as a pressure conduit when the reservoir is approximately at or above elevation 62.3 feet. Consequently, it is possible that the conduit would be pressurized for several days while a flood event is being accommodated. Because of this, a pressure conduit could exist within the embankment with no means to facilitate emergency closure (see Recommendation 5).

Photo No. 3 - Principal Spillway and Low Level Outlet.
The principal spillway conical trash rack
is tilted and the pipe encasing the low
level outlet gate stem is broken.

- (7) Remove the small amount of debris on the upstream face of the dam, particularly near the conical trash rack on the riser.
- (8) Repair the small erosion area of the left abutment contact on the downstream side.

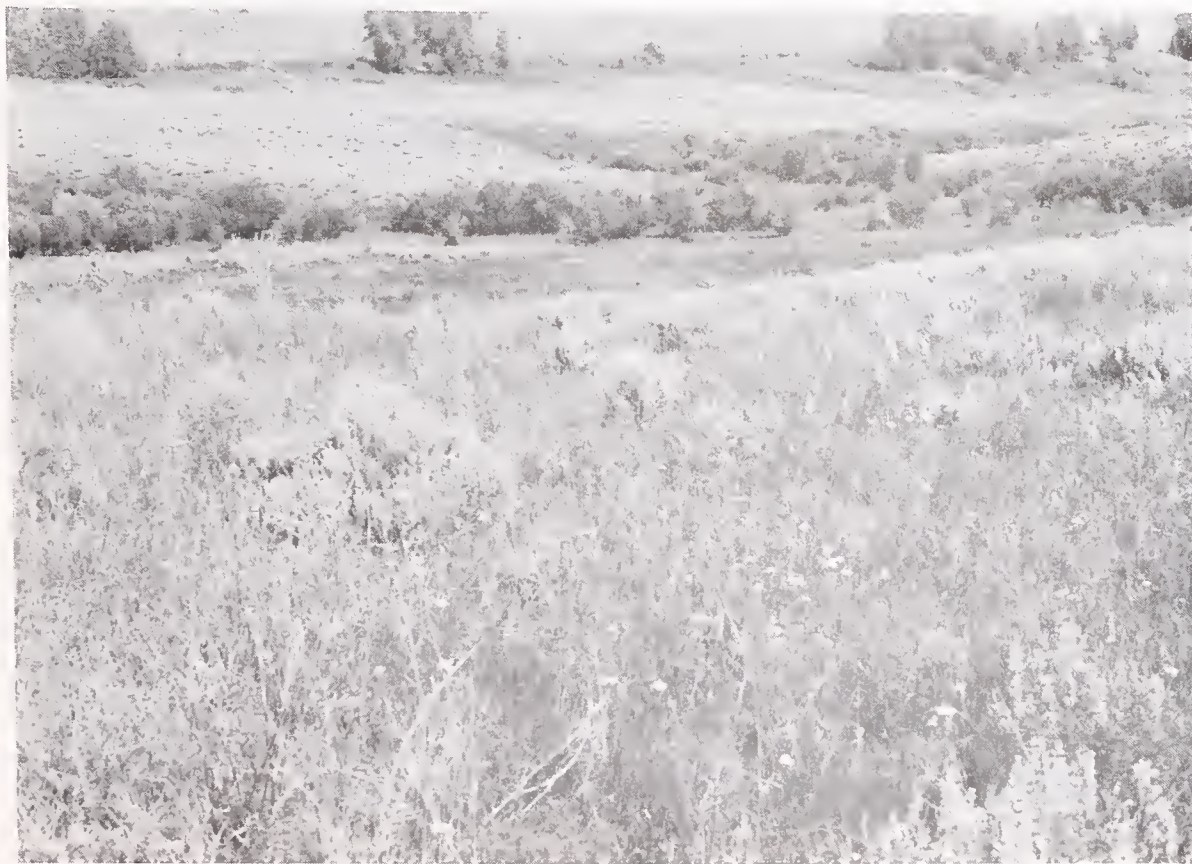
The emergency spillway is operational and in good condition. The spillway channel is covered with grass, weeds and sagebrush.

Photo No. 4 - Emergency Spillway.
The emergency spillway is covered with
grass, weeds, and sagebrush.

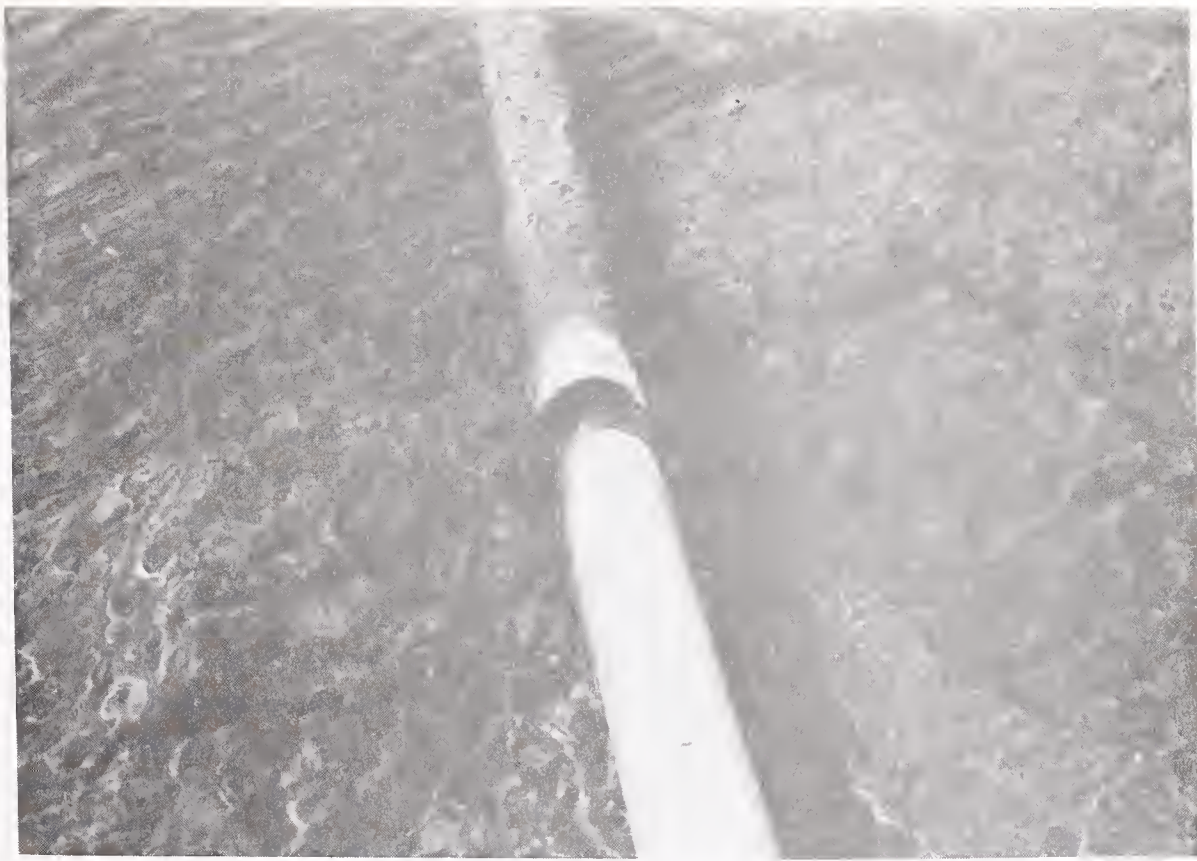
The 2.5-inch galvanized steel pipe which encloses the gate stem is broken at a threaded connection and is allowing water to enter

(Photos 3 and 5 of Appendix B). Wave erosion of the gravel and hard shale, used as riprap on the upstream face, uncovered the gate stem pipe and undermined the pedestal. The fracture of the pipe was likely due to ice pressure and pedestal settlement. This is designed to be a closed system containing lubrication for the gate stem. The gate was partially opened during the inspection, and the low-level outlet system was operated for a short period of time. The water inside the steel pipe has not significantly harmed gate operation yet, but could become a problem in the future. The outlet pipe and gate were not inspected due to the high reservoir pool level and lack of appropriate equipment to inspect the small diameter conduit. It was not possible to tell if a complete seal of the gate can be obtained due to flow over the principal spillway crest. See Section 2.1.1 for a discussion of the stilling pool.

Photo No. 5 - Low Level Outlet.
The pipe encasing the gate stem is broken
and allowing water to enter.

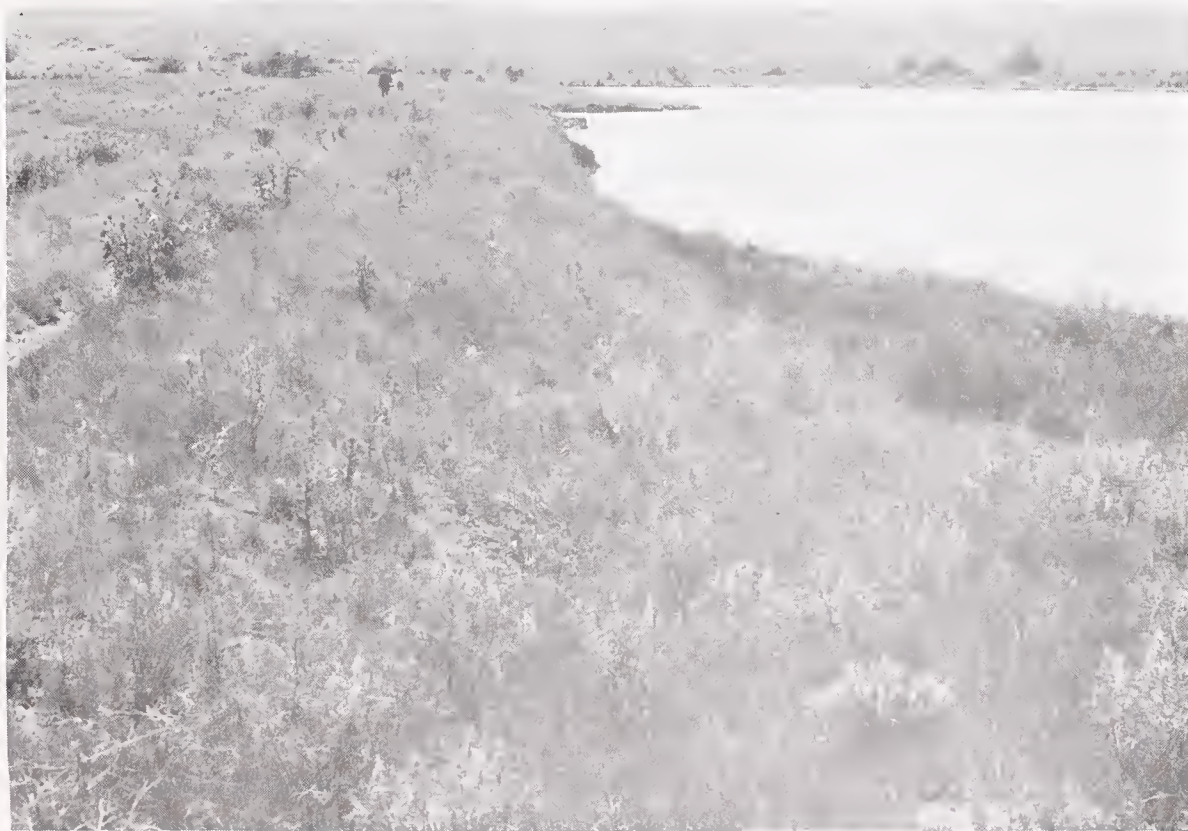
Jordan Dam is an earth fill structure which was completed in 1961. The dam has an estimated maximum structural height above the deepest point on the foundation surface of 38 feet and a crest length of 650 feet. A 240-foot wide spillway is located approximately 600 feet south of the right abutment contact. Based on field evidence and the surveyed profile (Exhibit C2), the optional dike shown on the construction plans (Sheet 1 of Exhibit C1) was apparently never constructed. The crest width was designed to be at least 14 feet (Photo 6 of Appendix B), and approximate field measurements verify this width.

Photo No. 6 - Dam Embankment.
The dam crest, shown from the left abutment,
is approximately 14 feet wide.

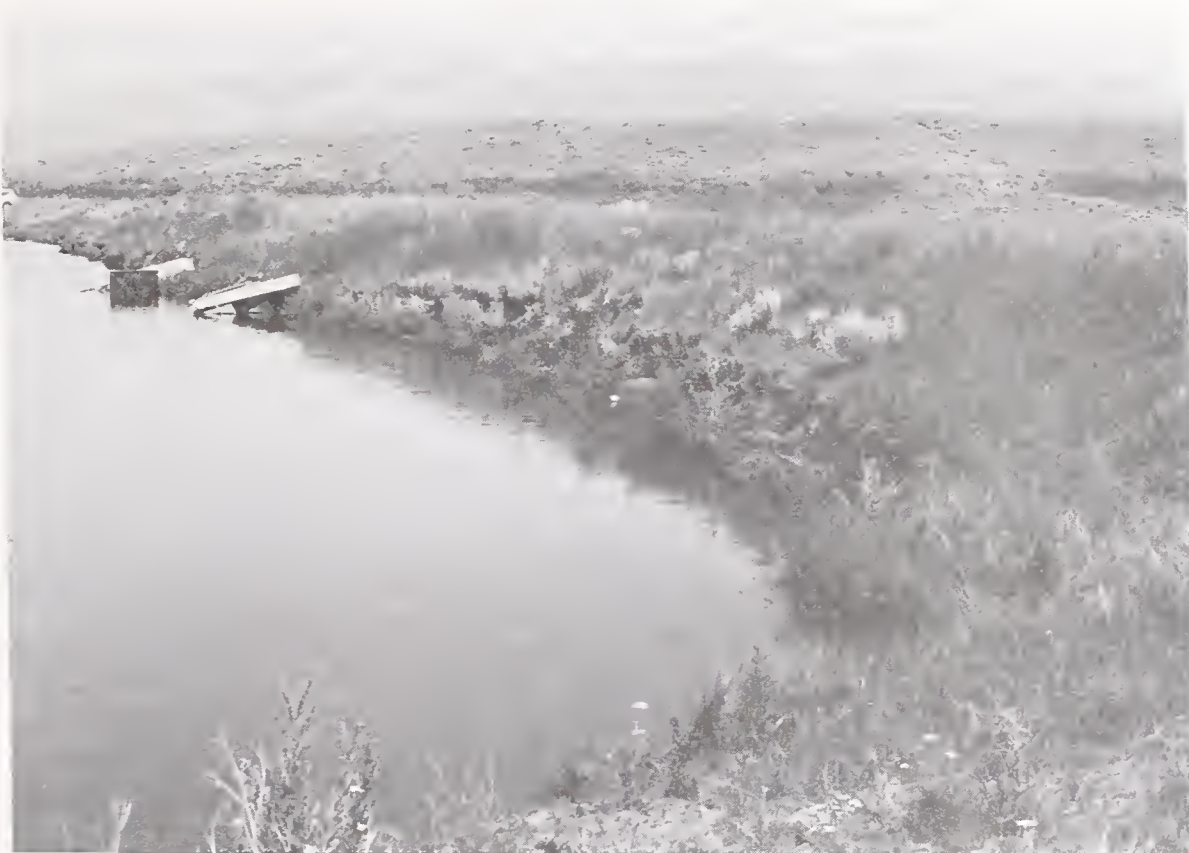
Photo No. 7 - Dam Embankment.
The upstream dam embankment is covered with grass, weeds and sagebrush.

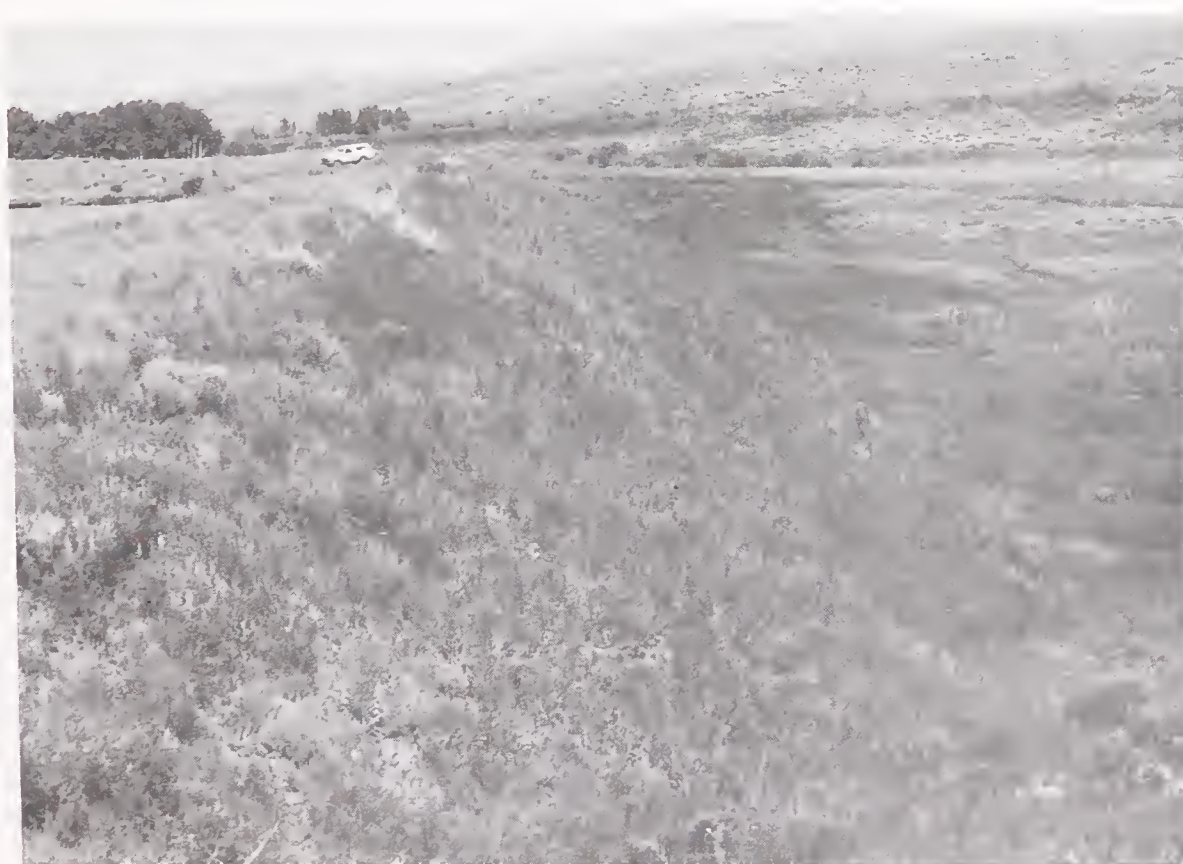
Photo No. 8 - Dam Embankment.
The downstream dam embankment is covered with weeds, sagebrush and grass. Seepage is evident on the left abutment.

- (6) Install piezometers in the embankment, abutments, and foundation to evaluate the seepage conditions. Establish a regular monitoring program for the underseepage and abutment seepage. Particular attention should be given to periods when the reservoir pool is relatively high.

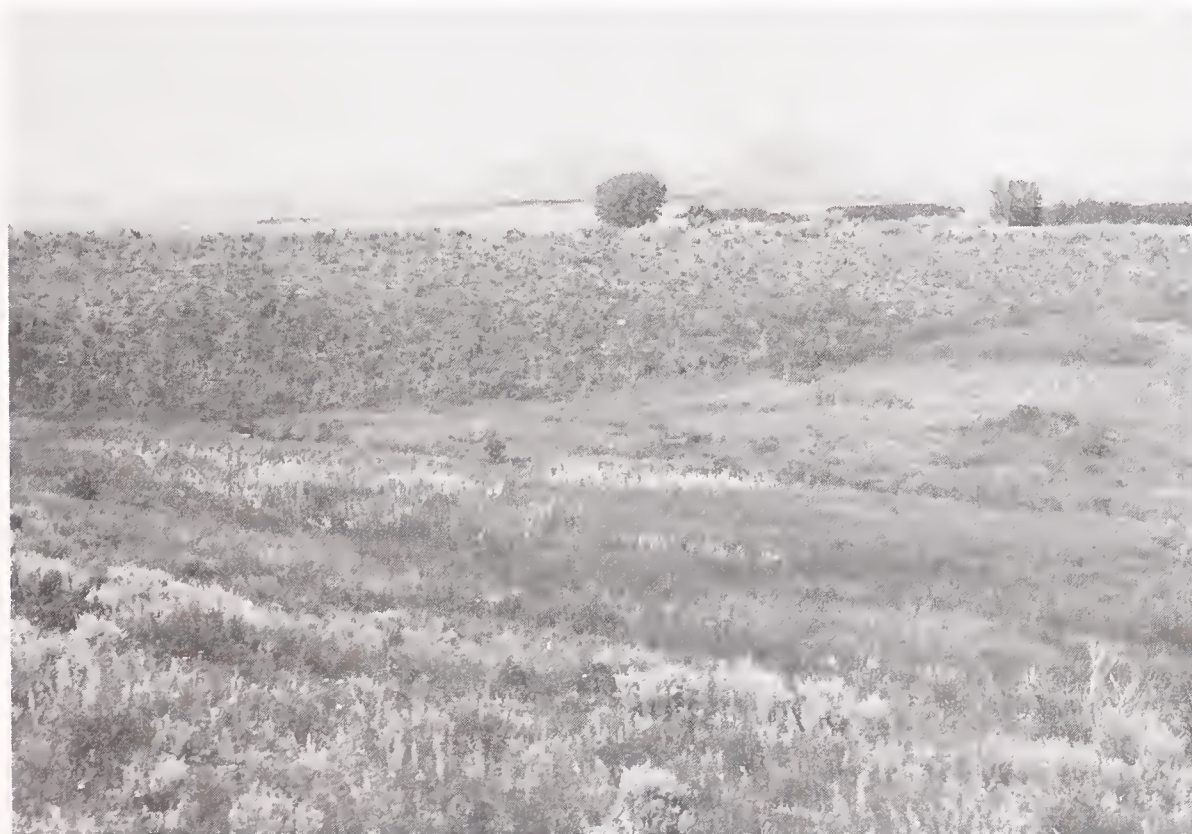
Seepage is occurring at the left abutment and is identified on the right side of the photo by the tall grass at the toe of the embankment.

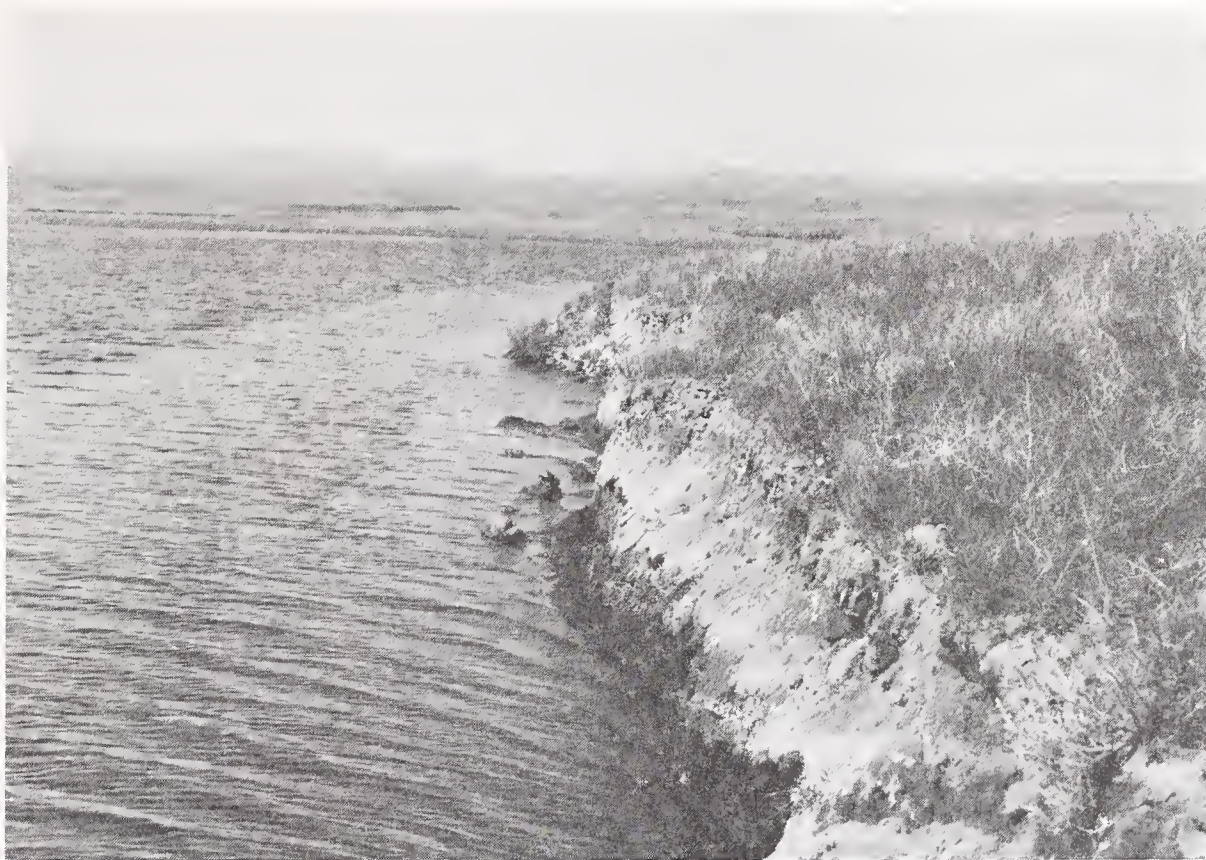
Photo No. 11 - Dam Embankment.
Sections of the upstream dam face have
been oversteepened due to wave action.

- (1) Immediately develop, implement, and periodically test an emergency warning plan for use in the event of dam distress.
- (2) Reshape the upstream face of the dam above the berm and along the natural shoreline of the right abutment to the proper slope. Place a weather-resistant, properly designed, rock riprap material in this area, and in any area below the berm which appears deficient.

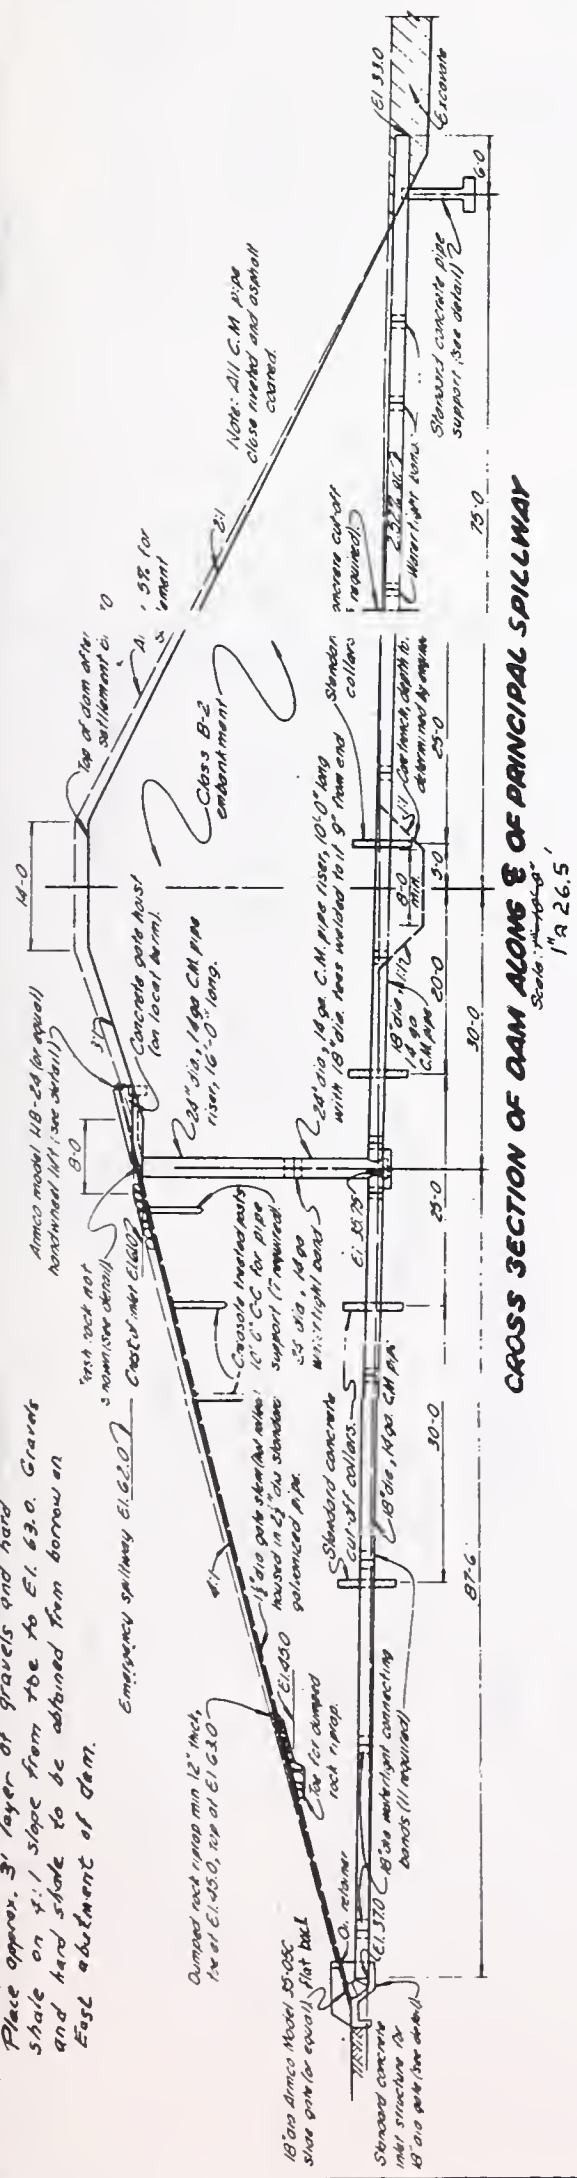
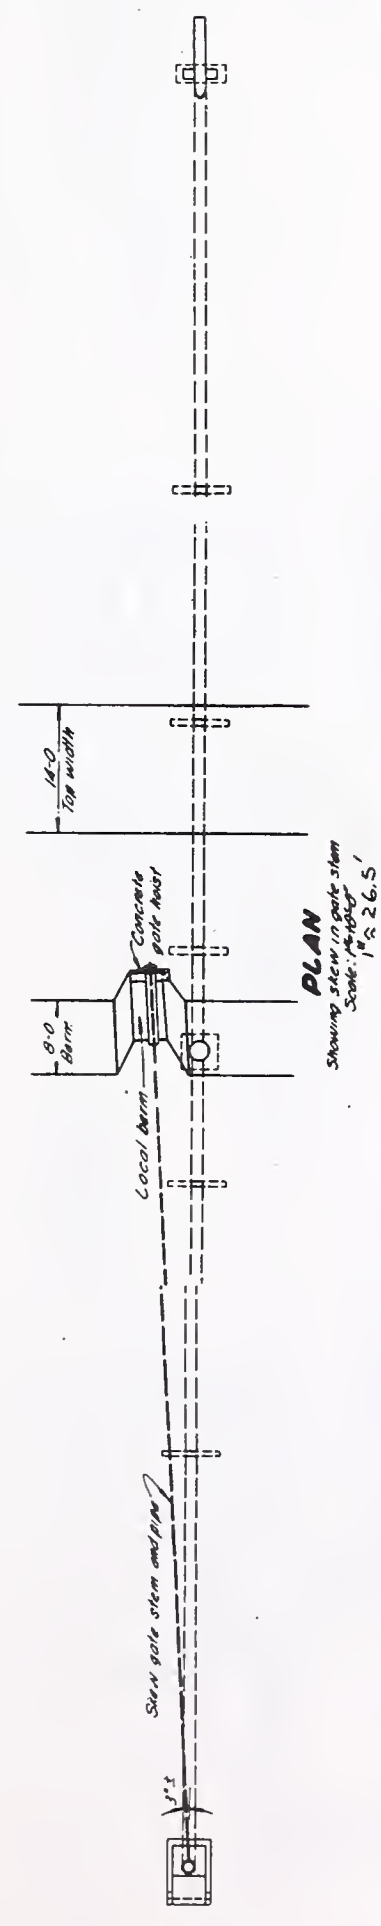
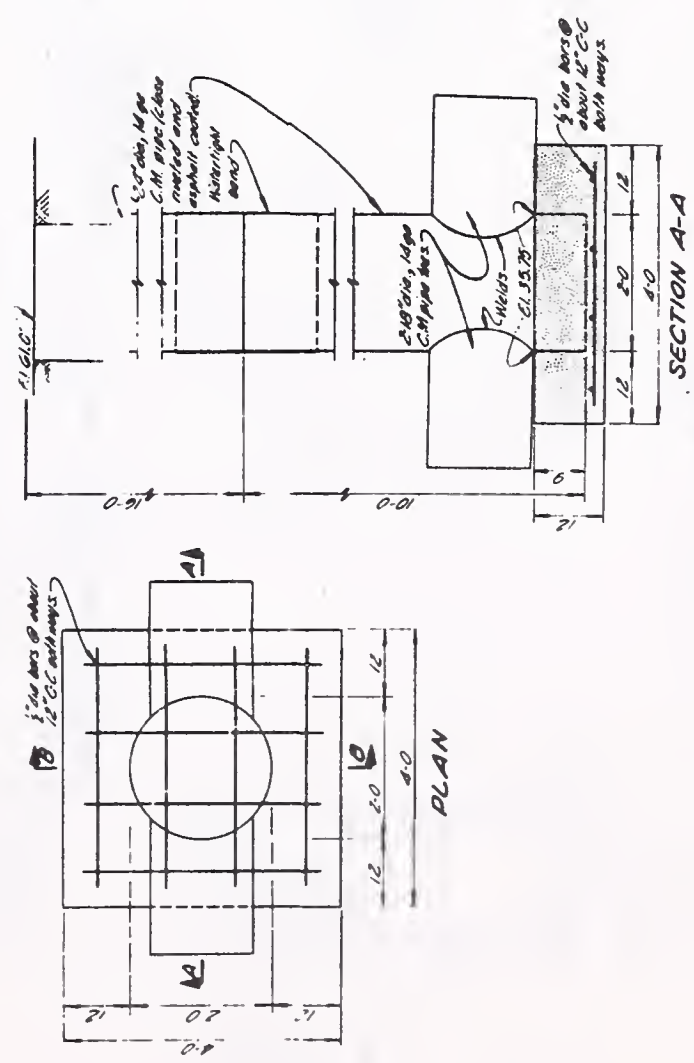
EXHIBIT C1
SHEET 3 OF 4

The construction plans (Sheet 3 of Exhibit C1) indicate the upstream face of the dam has a slope of 1V on 3H down to an 8-foot wide berm located at elevation 61.0 feet (see note on page viii), then flattens to 1V on 4H. Field measurements verified the slope above the berm, but due to the pool level, the slope below the berm could not be verified. The upstream face below the berm was designed with a 36-inch cover of loose gravel and hard shale. Damages resulting from a lack of sufficient riprap protection are discussed in Section 2.3.3. There is a moderately dense cover of grasses, weeds, and sagebrush on the upstream slope above the June 26, 1980 water surface (Photo 7 of Appendix B). Debris on the upstream face is limited to very small material, which is expected because of the nature of the drainage area.

Details provided on Sheet 3, Exhibit C1 indicate the embankment cross section consists of class B-2 fill material. The construction specifications describe this material as clayey-silts (ML-CL Unified Classification) with a maximum dry density of 105 pounds per cubic foot and an optimum moisture of 21 percent. A maximum particle size of 6 inches was allowed (Ref. 5). A detailed description of the as-built material is not available. Except for the filter and riprap materials, which are described in Section 2.3.4, the embankment is apparently class B-2 throughout.

A riprap blanket has been placed on a portion of the upstream face of the dam. The blanket is loose gravel and hard shale. The plans indicate a 3-foot thick layer of this material has been placed from the toe up to elevation 63.0 (Sheet 3 of Exhibit C1). The riprap has occasionally slipped down the upstream embankment face due to erosion and wave action. This riprap is not adequate for protection of the upstream face.
